# Quality Built® Tech Alert

June 9th, 2014

Volume 2, Issue 4

## Two problems with every 1-coat installation

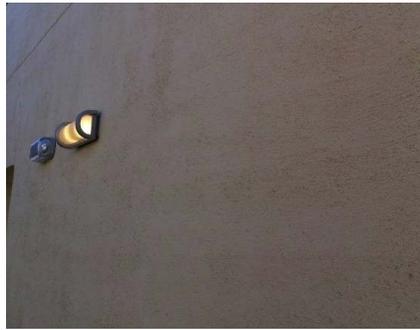
Photo 1

Quality Built inspects hundreds of homes each week clad with one-coat stucco. Let's start by clearing up possible misconceptions about one-coat stucco. Originally one-coat stucco was literally one coat of stucco. The original system had drawbacks, in terms of the finish of the product, with uneven color distribution and a coarse texture due to fibers in the plaster mix (Photo 1). Because of this, most one-coat being installed on the projects inspected today is actually two coats of stucco. This system uses one-coat to replace the scratch and brown coats of a traditional three-coat system. One-coat is most often applied over a foam board, not be confused with EIFS (Exterior Insulation Finishing System). However, this foam board does play a role in the problems that arise when installing one-coat. Unlike barrier EIFS, a one-coat system includes a drainage plane behind the foam board (usually a house-wrap or building paper) and metal lath. The foam provides backing for installing the plaster and a semi-flexible support for the life of the plaster. One-coat plasters often include modifiers to increase crack resistance which will allow some flexing of the stucco cladding during wind loads, etc. However, this does not mean that the one-coat stucco system will not crack (Photo 2).

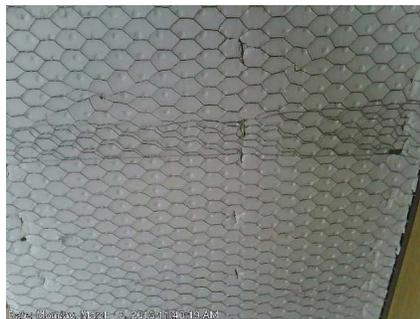
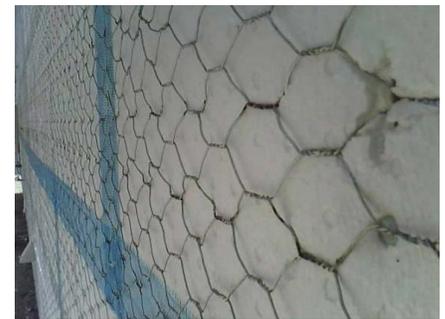
Photo 3

Secondly, one-coat stucco is applied over lath which is installed over the foam and attached to the framing. The lath is often attached to the framing using a pneumatic staple gun as this is a time-efficient tactic to attach the lath. The problem is that the foam offers very little resistance to the staple. If the wood framing is not of the proper density or if the gun is over-pressurized, the staple pulls the lath into the foam. When the lath is pulled tight against or into the foam, the lath is not furred off the foam and not properly embedded in the stucco (Photos 3&4). This lack of embedment stems from the first problem which is the overdriven fasteners.

This lack of embedment caused by the overdriven fasteners is a serious problem. Stucco is a cementitious product which means that it is structurally weak in tension and the shrinkage which occurs during curing creates tension within the stucco. Lath is made of metal which is strong in tension and is why we install stucco with lath embedded in it -- to resist the tension forces. Thus, if the lath is not properly

Both of these problems can result in expensive repairs and possible litigation. To reduce the risk associated with the installation of one-coat stucco, QB recommends using nails instead of staples as well as the use of third party QA provider. The QA inspections of the weather-resistive barrier should occur at two stages. The first should be prior to the installation of the foam and the second prior to the application of the stucco. The fasteners should be of a corrosion-resistant material, the type of which should be based on the other components to prevent galvanic corrosion from dissimilar metal contact. The fastener length will be a consideration because of the foam, which means a longer fastener will be required than for traditional three-coat stucco system. The nails shall be a minimum of 1-gauge roofing nails and shall penetrate the framing to a depth of one inch. Nails should be installed at the self-furring crimps of the lath and not overdriven. Hand nailing reduces the risk that the lather will not be aware of missing the framing or over-drive the fastener. By following these methods, the labor and material savings may be non-existent. However the energy requirements will be met and your risk will be reduced.

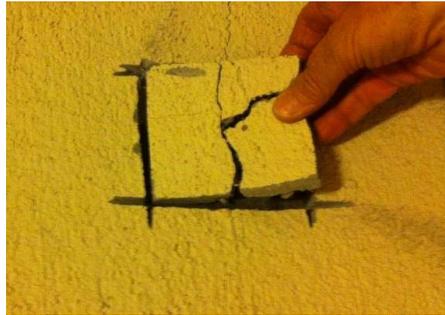
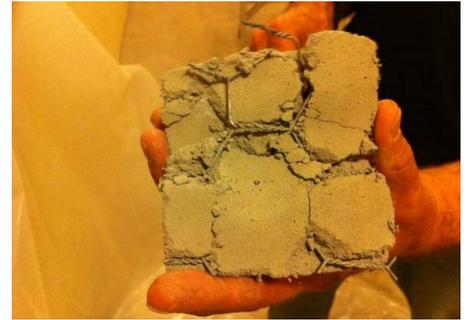
Photo 5

embedded in the stucco, it creates a weak spot. Test sections of stucco removed on several hundred structures with cracks proves many of the cracks were located at areas where the lath was not properly embedded (Photos 5&6).

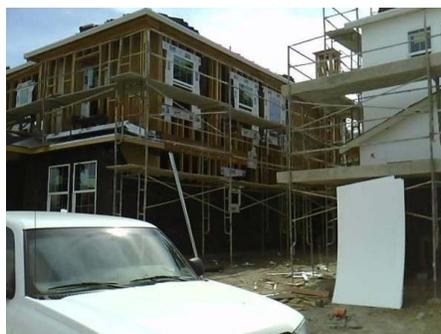
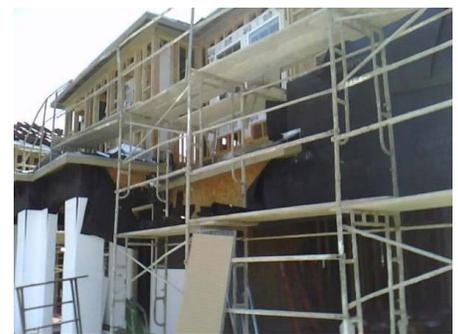
Photo 7

While stucco cracking looks bad and may upset homeowners, it does not mean that the house will leak or experience water intrusion. This second common problem creates a risk that water intrusion will occur and the foam board application increases this risk. The problem: holes in the weather-resistive barrier can result in water intrusion. In a three-coat stucco system, the weather-resistive barrier is open and visible for inspection when sealant can be applied to patch minor holes in the barrier right up until the first/scratch coat of stucco is applied. In a one-coat application, the barrier is covered with the foam board before the staples for the lath are applied. In many cases, unless the builder specifically requires a delay in foam application to allow for inspection of the barrier, the foam is applied within hours - if not minutes - of the barrier application (Photos 7&8).

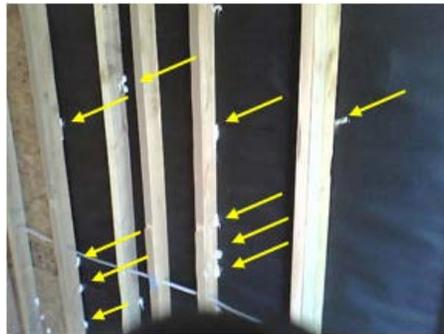
Photo 9

Following the installation of the lath, the one-coat installer is supposed to go inside the unit and seal all visible holes in the barrier (Photo 9). He cannot, however, see or seal holes that occur over wood framing members or wood sheathing. In some cases he may try to seal fasteners that missed from the inside by sealing the fastener at the sheathing which will not work as the seal will not be at the weather resistive barrier (Photo 10). If the installer misses the mark with the gun on open stud framing, the damage can be seen and corrected. It is when the damage cannot be seen that the risk is greatest. Water leaking through the weather-resistive barrier to the OSB sheathing may go unnoticed until the sheathing and other components are deteriorated. The sequence of installing the lath after the foam is inherently necessary in a one-coat application; however, it is this activity that increases the risk to the builder.
